CWM GWYDDON SCHOOL

ARBORICULTURAL SURVEY REPORT

Caerphilly County Borough Council

February 2021

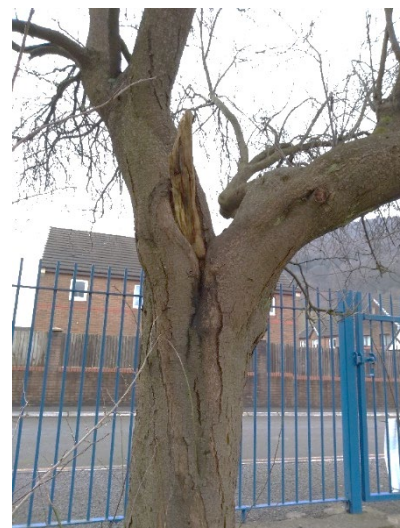
A small row of blossom trees providing visual interest and structure, sited on a raised verge near the entrance gate. The two cherry plum, *Prunus cerasis*, are mature for the species and T3 is showing the early signs of structural failure, hence U category. No works are anticipated in this location – but the need to retain the localised ground levels should be considered in any design if the trees are to be retained.

Figure i T3 with decay and lost branches from main union

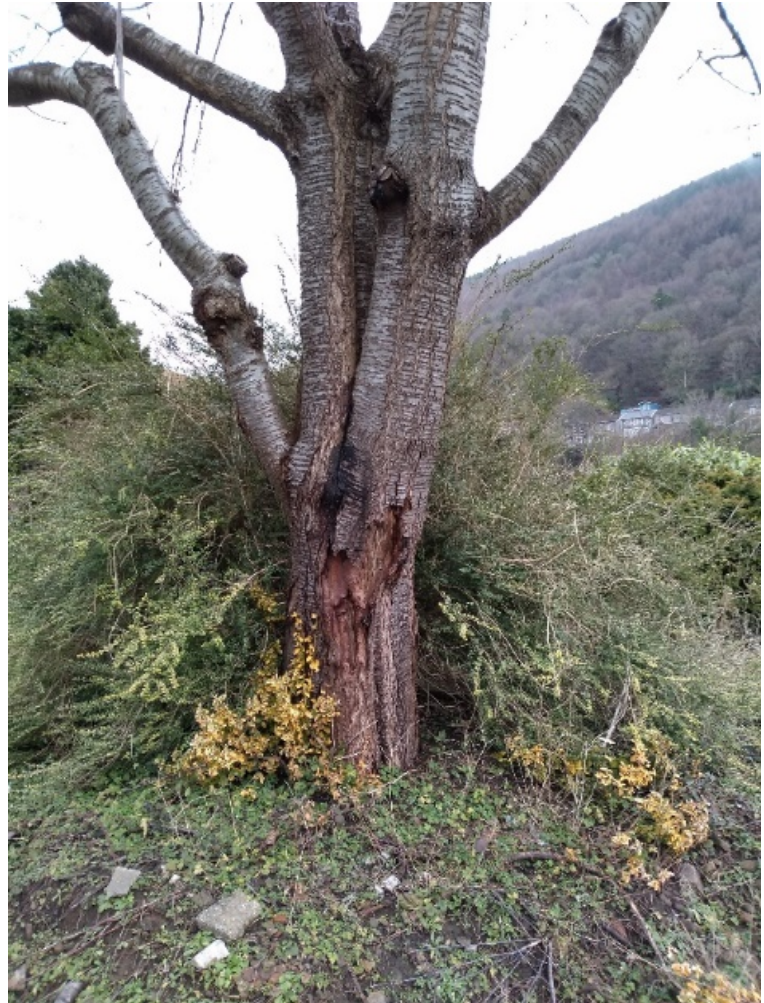
This group sits among wider groundcover and shrub planting within beds in what was a courtyard style garden. T9, an ornamental cherry, is very mature and in poor condition with damage to the stem and poor branch structure. It has had the ground surface removed very close to its root system, which raises concerns about future health and stability.

Figure ii T9 with stem damage and exposed roots

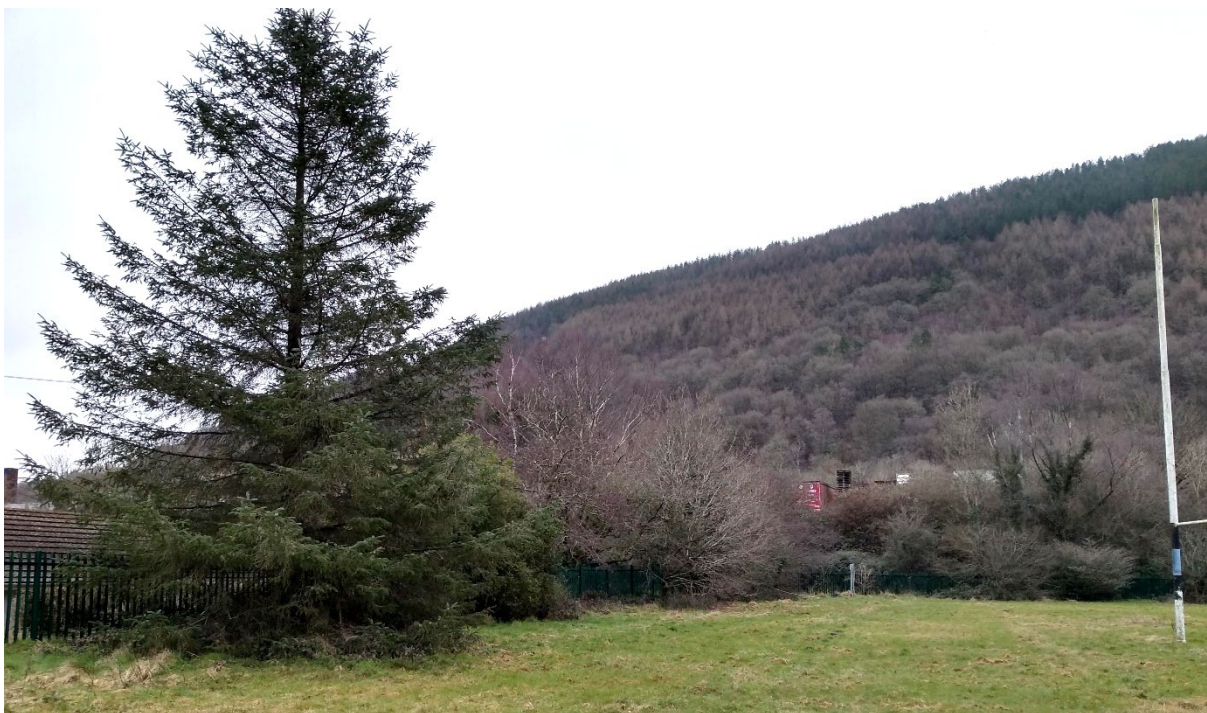
An unmanaged and thus slightly overcrowded line of primarily native species which would benefit from some selective thinning to allow tree crowns to develop to their best form. It does provide a useful function of screening the sports pitch beyond and defining the school site as well as integrating the site with the wider landscape. The spruce, *Picea spp.* T22, in the middle, forms an interesting large feature tree.

There appears to be some Japanese Knotweed amongst T24 and T25 in the NW corner. This should be confirmed in the growing season. Treatment of this would need to avoid excavating tree roots or unidirected use of herbicide which could affect the trees via their leaves.

Figure iii Northern boundary group with T22 in foreground

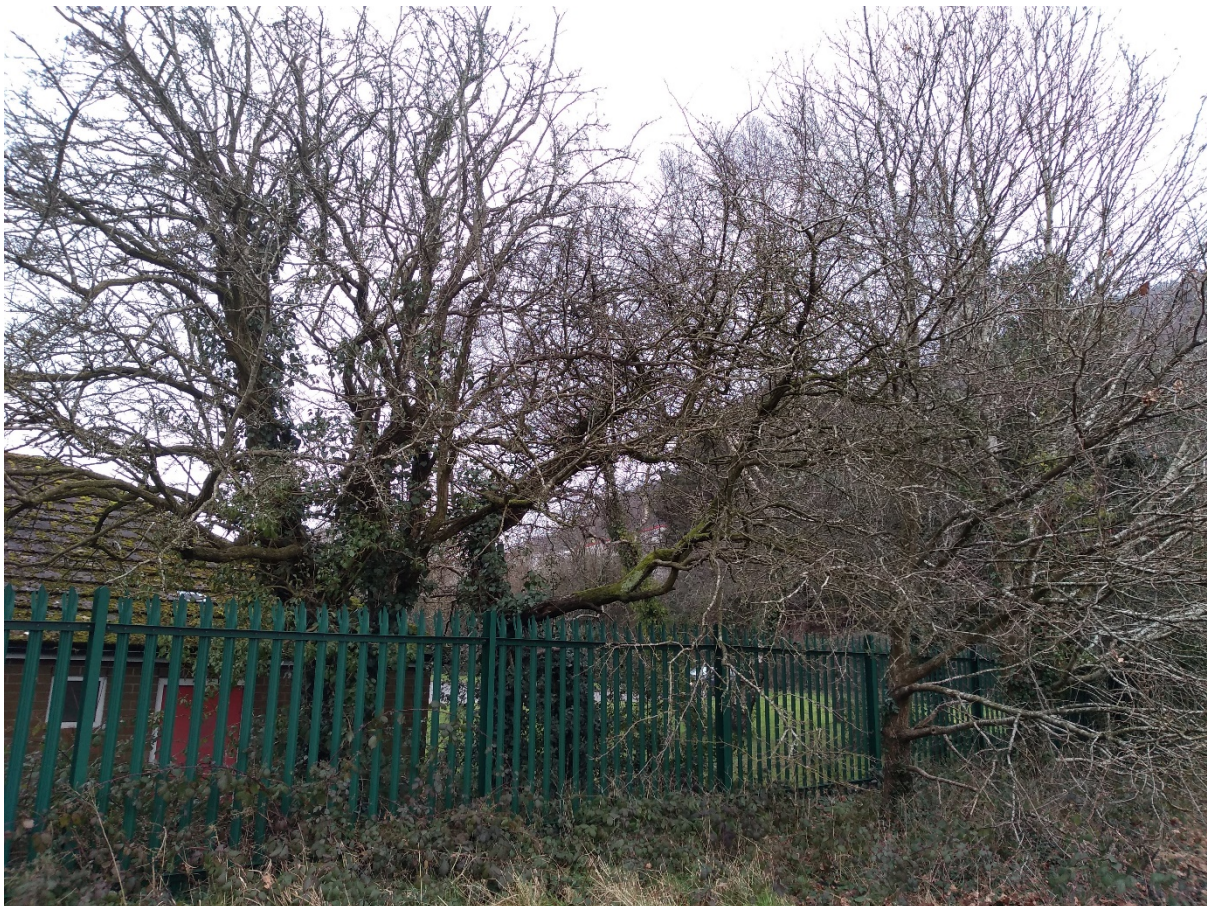
The trees on the other side of the fence effectively form part of the same overall boundary group. These are generally more mature and established specimens. Notably the hawthorns T26 and T27, and hollies T29 and T30, are at a stage where they provide good wildlife habitat as well as dense foliage. The birch T32 is also very large and a feature tree for amenity and shade due to its location in the centre of the lawn. Measurements for these trees were visually estimated from the school site.

Figure iv Hawthorns T26 and T27
