Bat Survey: Trinity Fields School, Caerphilly Road, Ystrad Mynach, Hengoed, CF82 7XW

Instructed by: Caerphilly County Borough Council

Reported by: Ecological Services Ltd
10 Mount Pleasant, Llanelly Hill, Abergavenny, Monmouthshire, NP7 0NT

Author	Date	Version
Rich Watkins	February 2023	V2.0

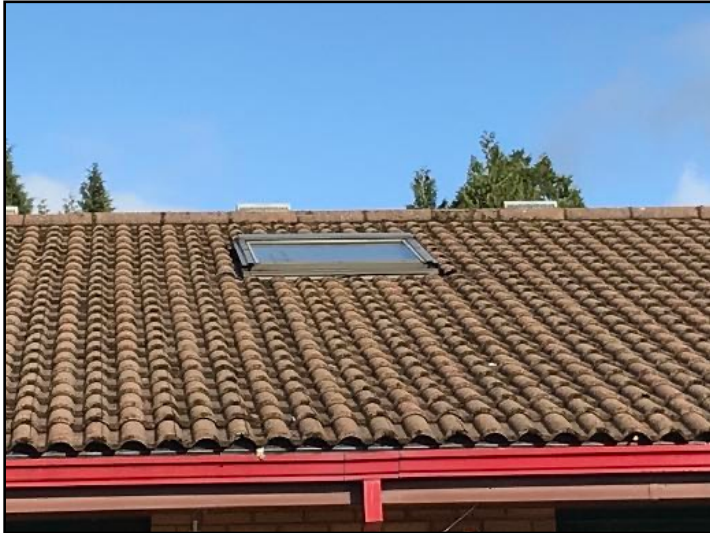
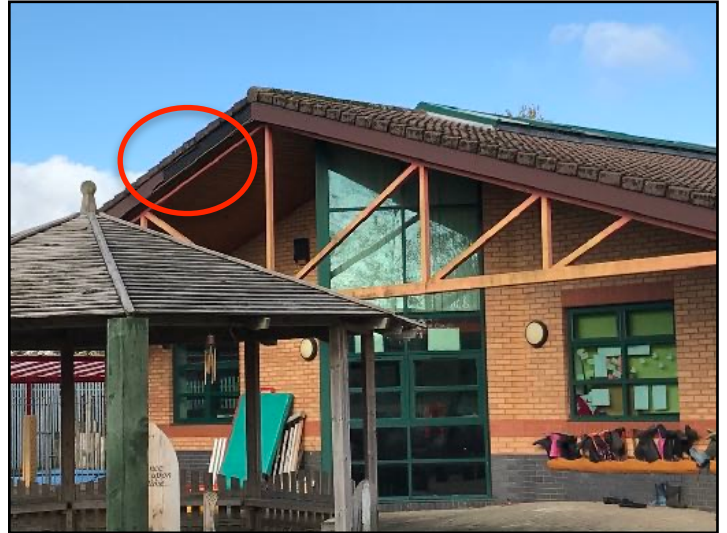
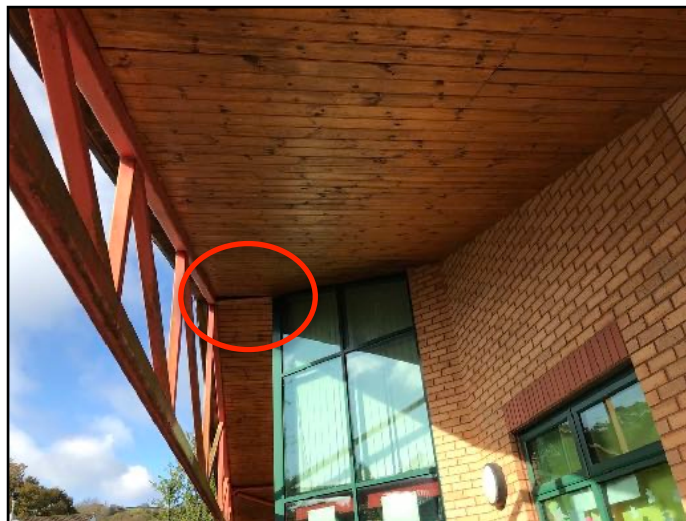
6.3 Due to the age and condition of the building there were limited opportunities for bats to roost. Those that were available were deemed as having low to moderate potential. There was a missing section of barge board on the south gable end and dislodged pieces of wooden panelling at the south gable apex. The roof line appeared to be generally tight but with occasional slightly raised tiles around the roof lights. A 1FF bat box was noted on the south facing gable end of the building during the scoping survey. The building was classed as low potential for roosting bats, however, there are confirmed bat roost records in the south western corner of the building directly where the new extension is proposed.

6.5 Examples of apertures allowing access to cavities in the building:

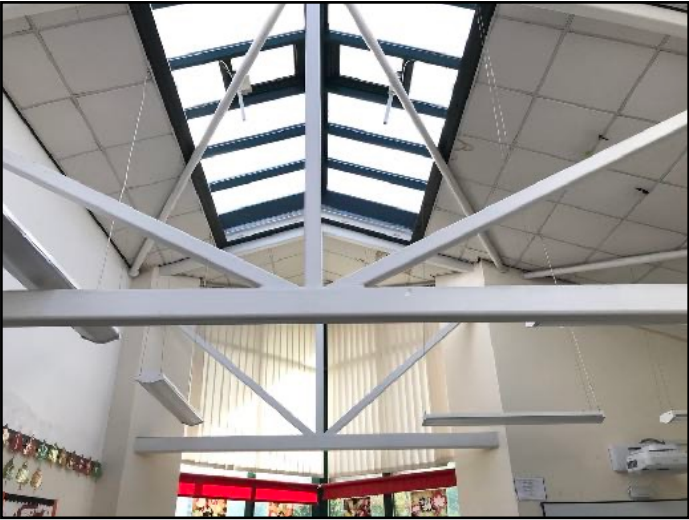
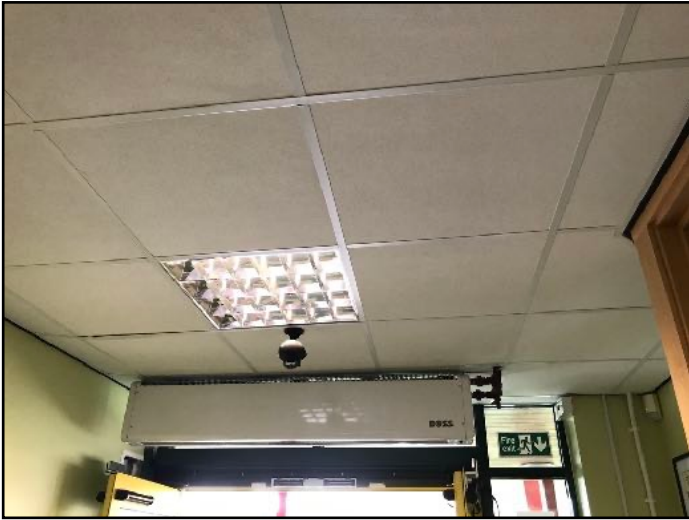
7.2 No accessible roof space was present. There was a suspended ceiling present throughout the building. Sections of the building were open to the ridge line which had glazing along it allowing natural light into the building.

7.3 Internal view of the school:

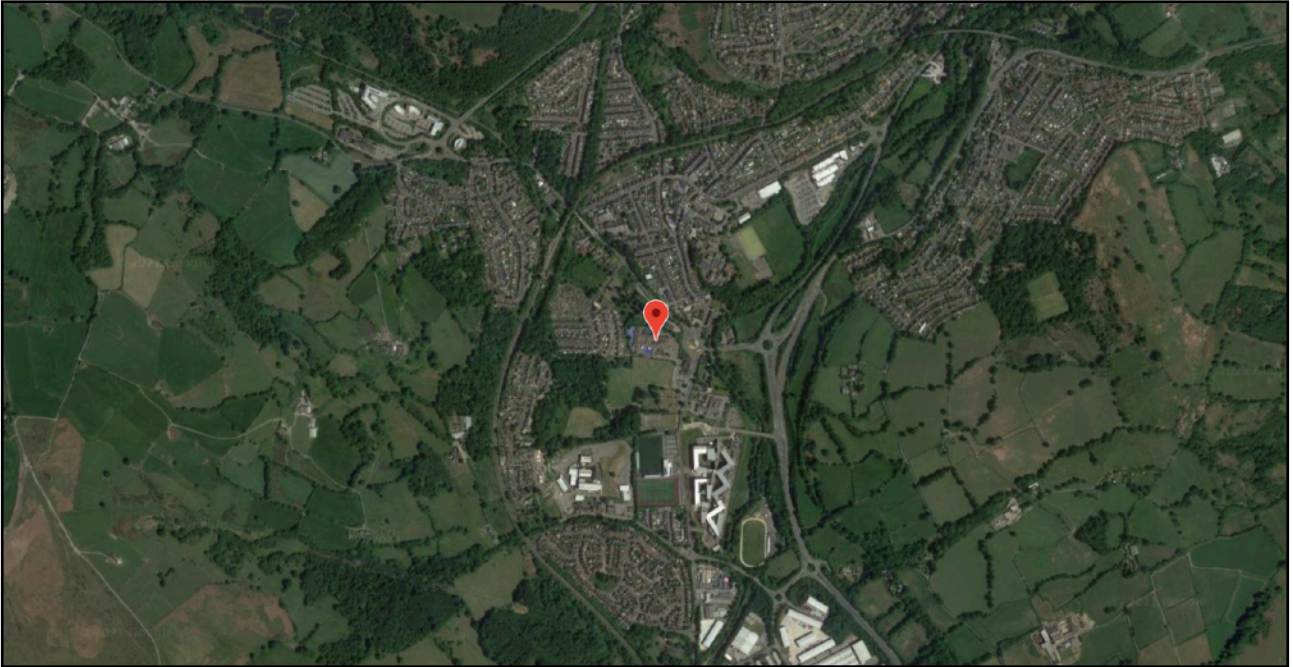
Aerial Site Photo

The site in its wider environment showing excellent ecological connectivity to the surrounding habitat.
