**Former Pontllanfraith Comprehensive  
School**

**Proposed Sports Hall**

Supplementary Geo-Environmental and Geotechnical Assessment

ESP.7977.3717

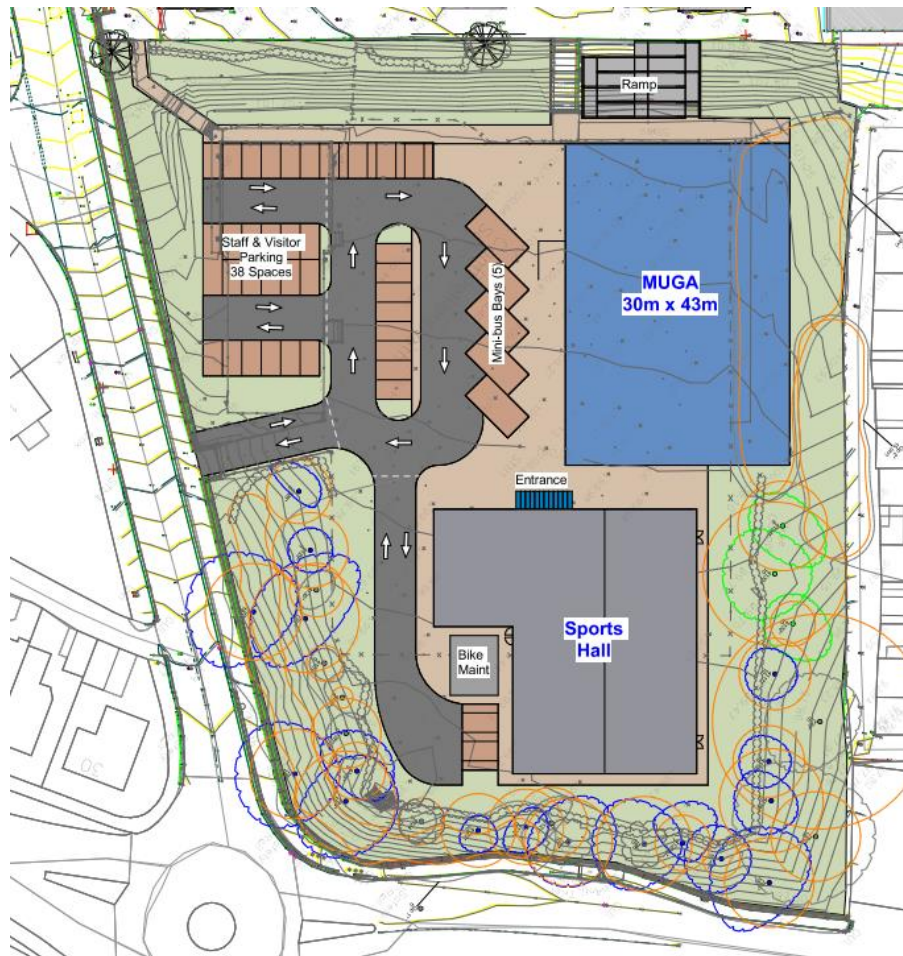
Insert 1: Proposed Site Layout (Provided By Client)

The proposed development will comprise the construction of a sports hall building, with areas of MUGA pitches, hard standing and landscaping. The proposed development as we understand it, is presented as Insert 1 below. Based on the above, we understand that the proposed structures would be classified as Geotechnical Category 2 (BS5930:2015).
